Monitoring stormwater bioretention unit performance for WSUD

Chris Derry
Hawkesbury Water Recycling Scheme
University of Western Sydney

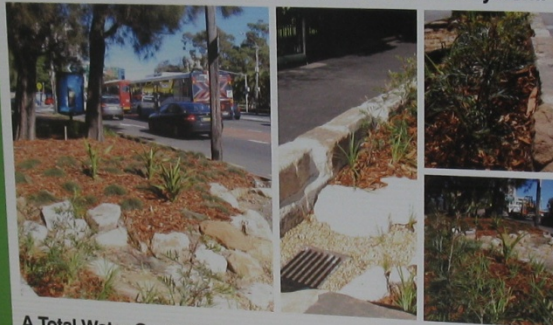
This raingarden may look like a regular garden bed, but it's also an underground stormwater treatment system.

The plants used are native to Sydney and have deep root systems that easily absorb rainwater and pollutants. The soil mixture is also designed to retain and hold rainwater, slowing down the flow.

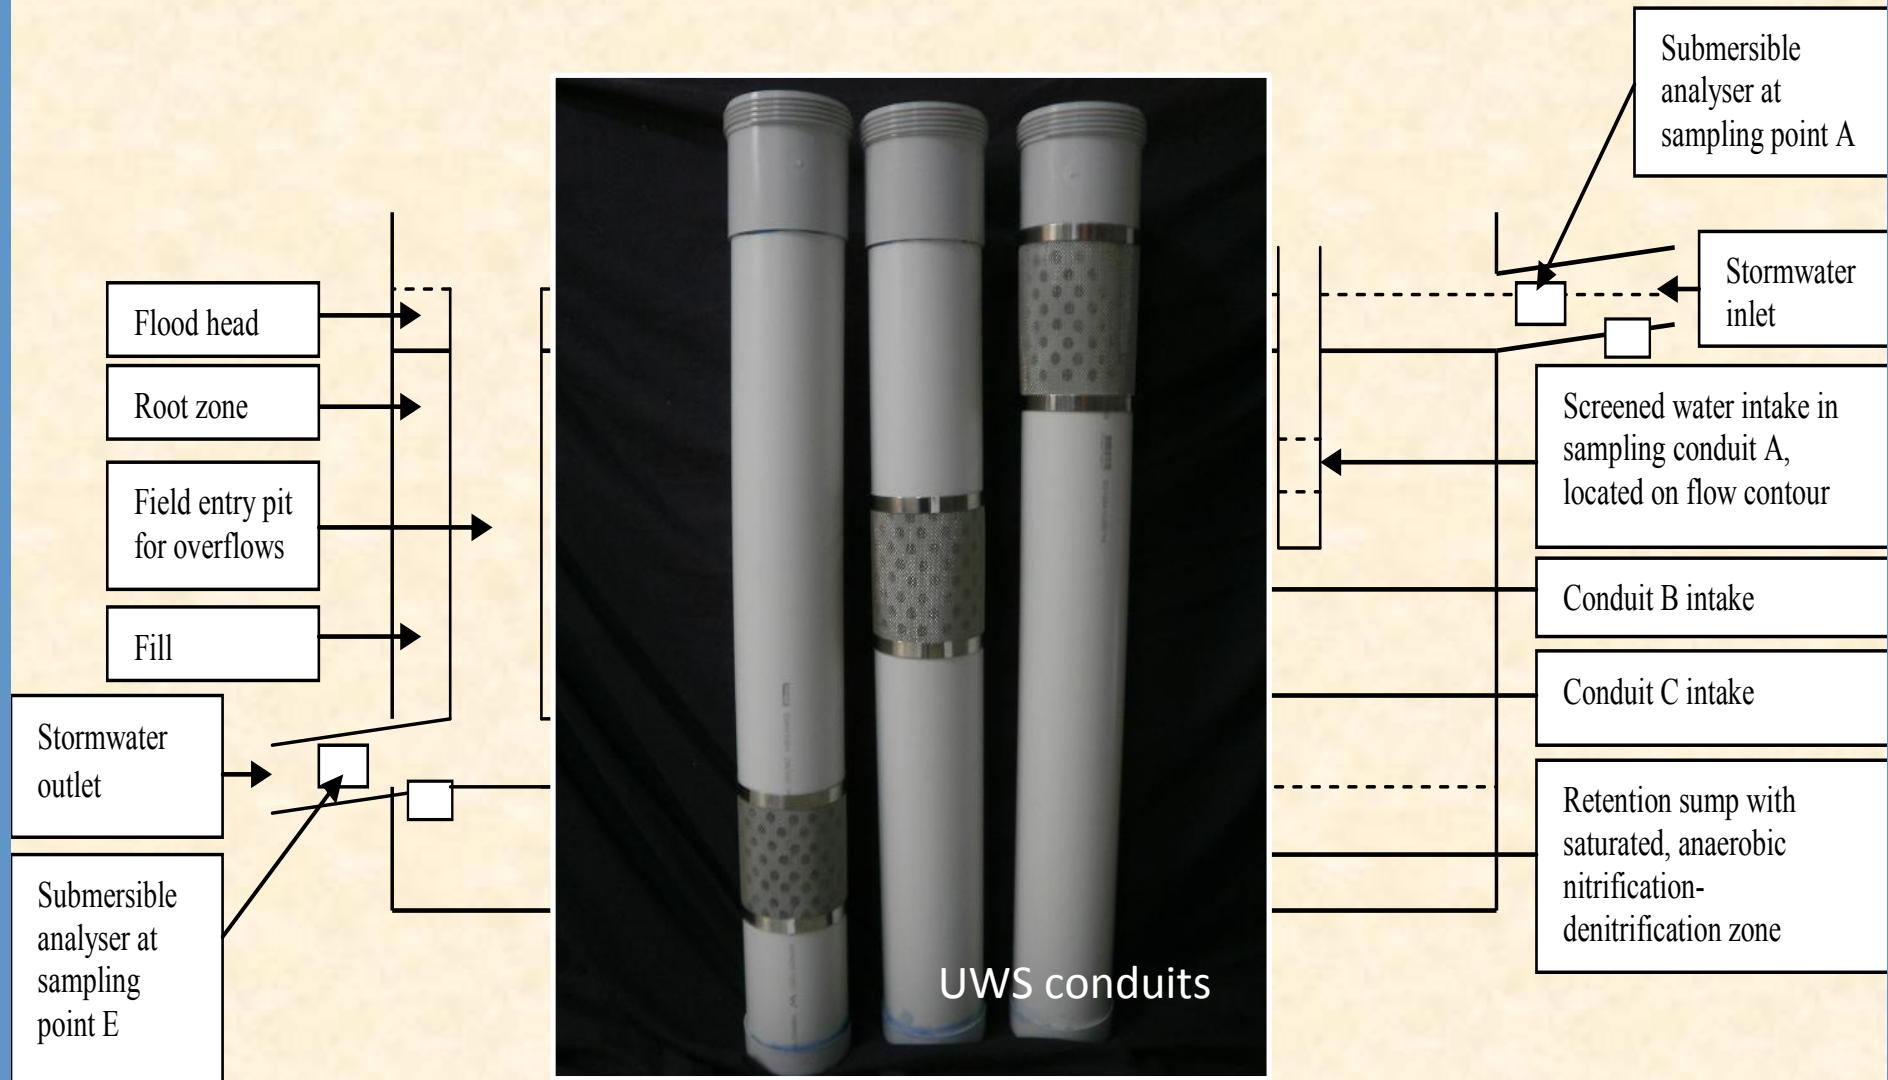
Bioretention unit with sampling conduits on flow contour

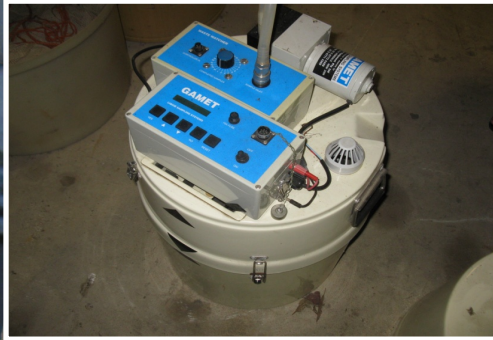
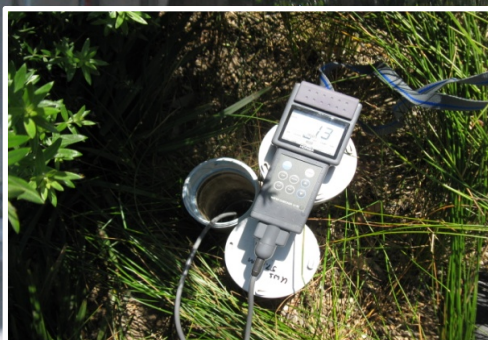
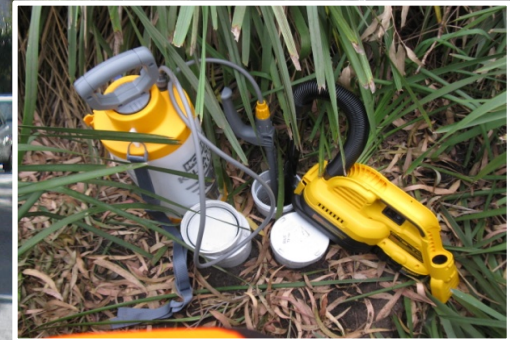
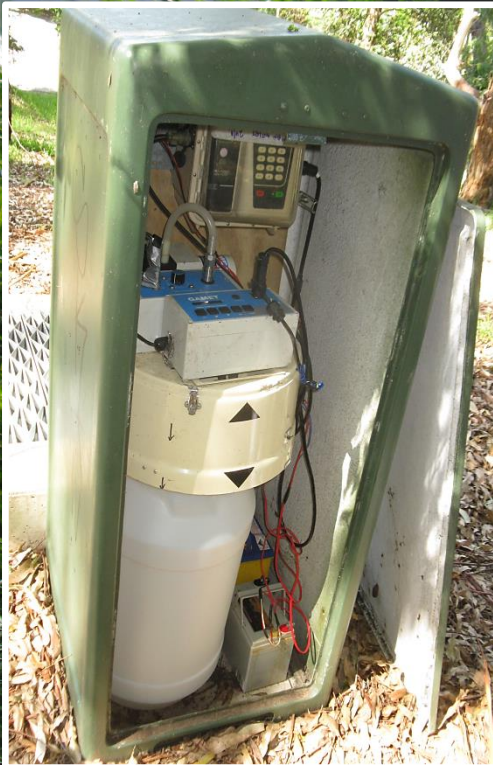
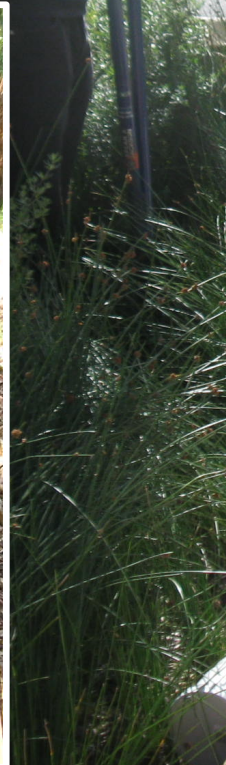
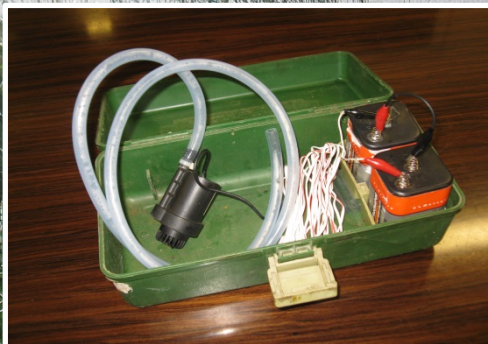
Development of conduit system

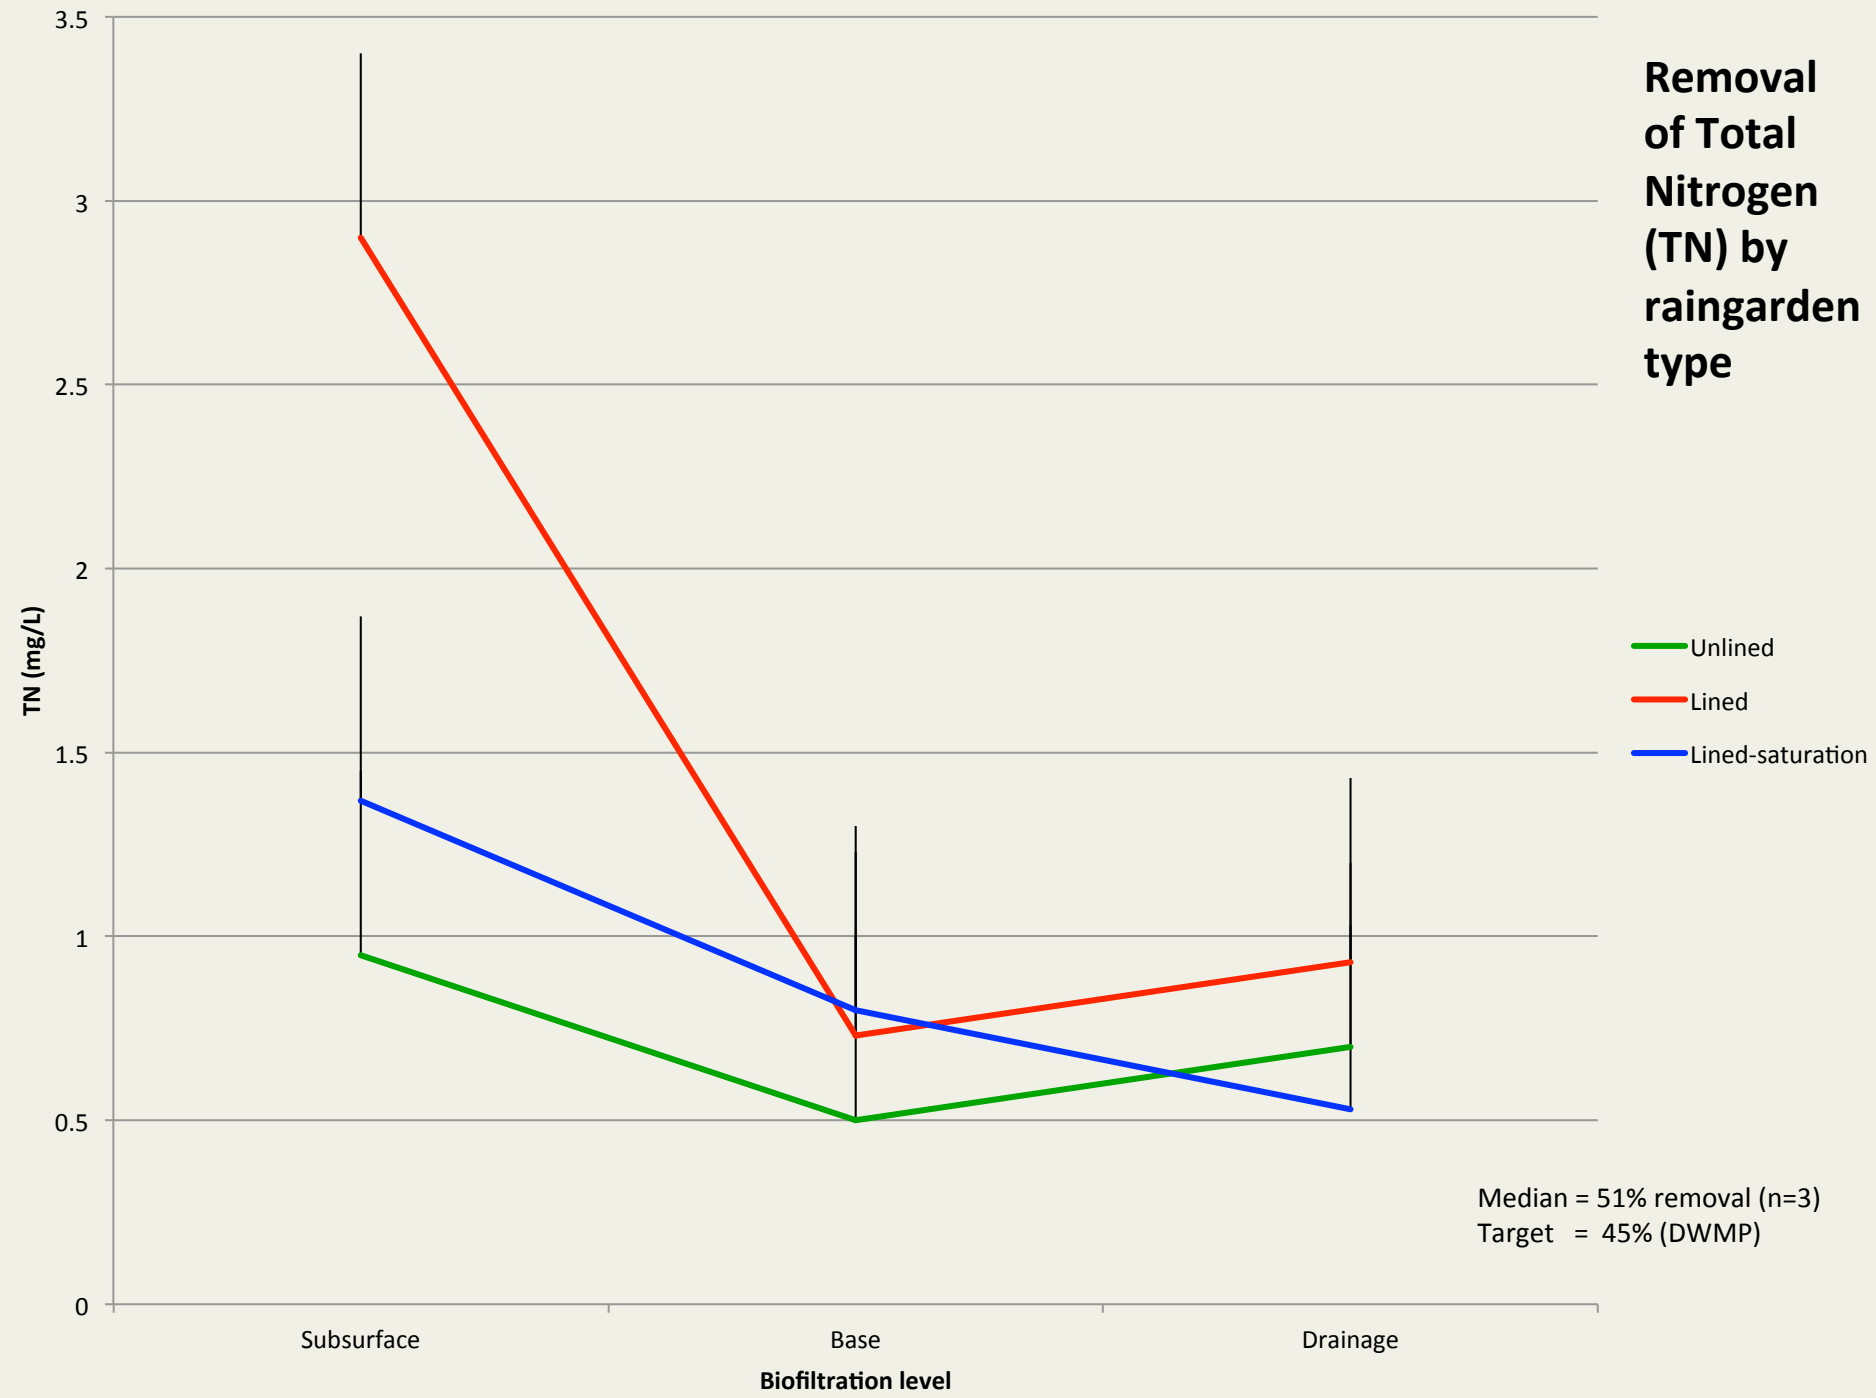
Removal of Total Nitrogen (TN) by raingarden type

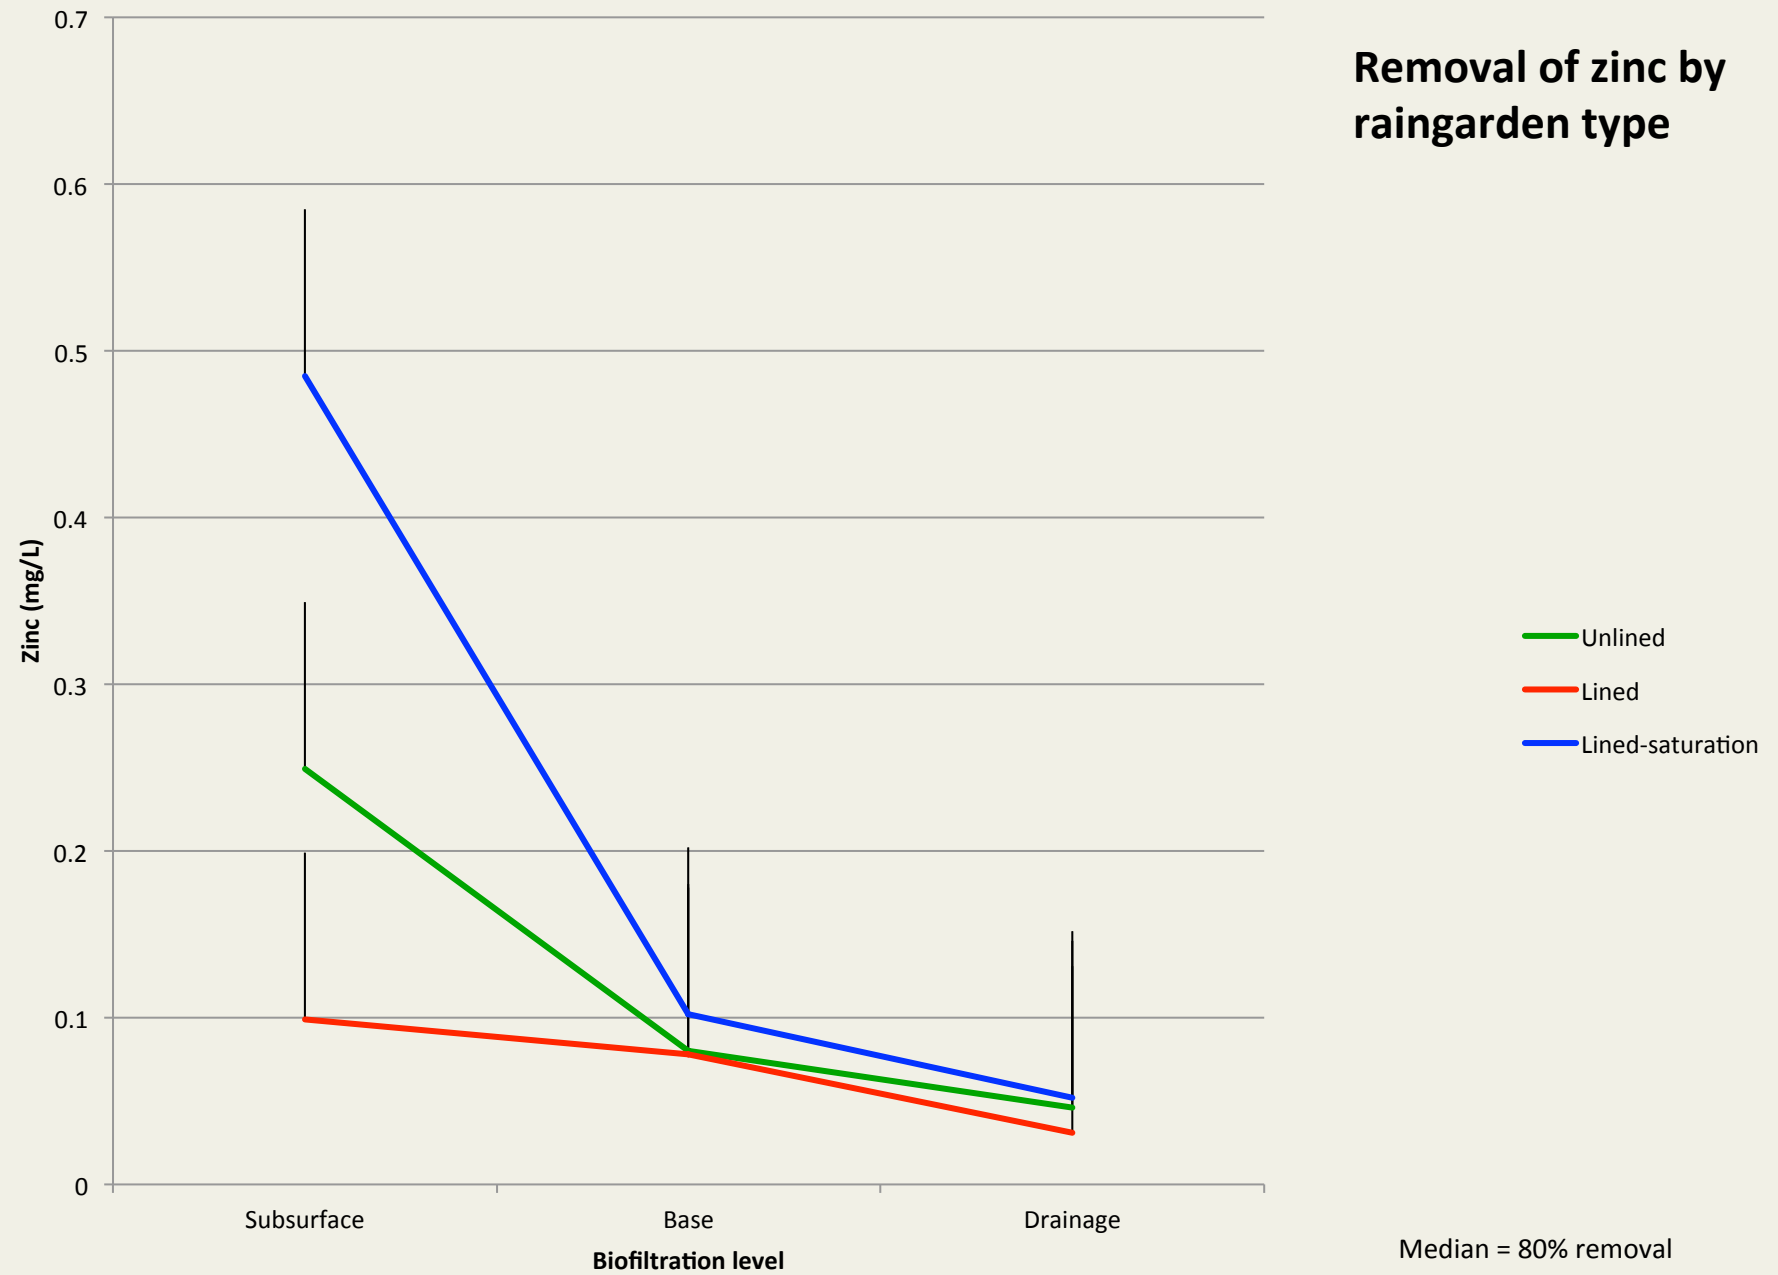
Removal of zinc by raingarden type

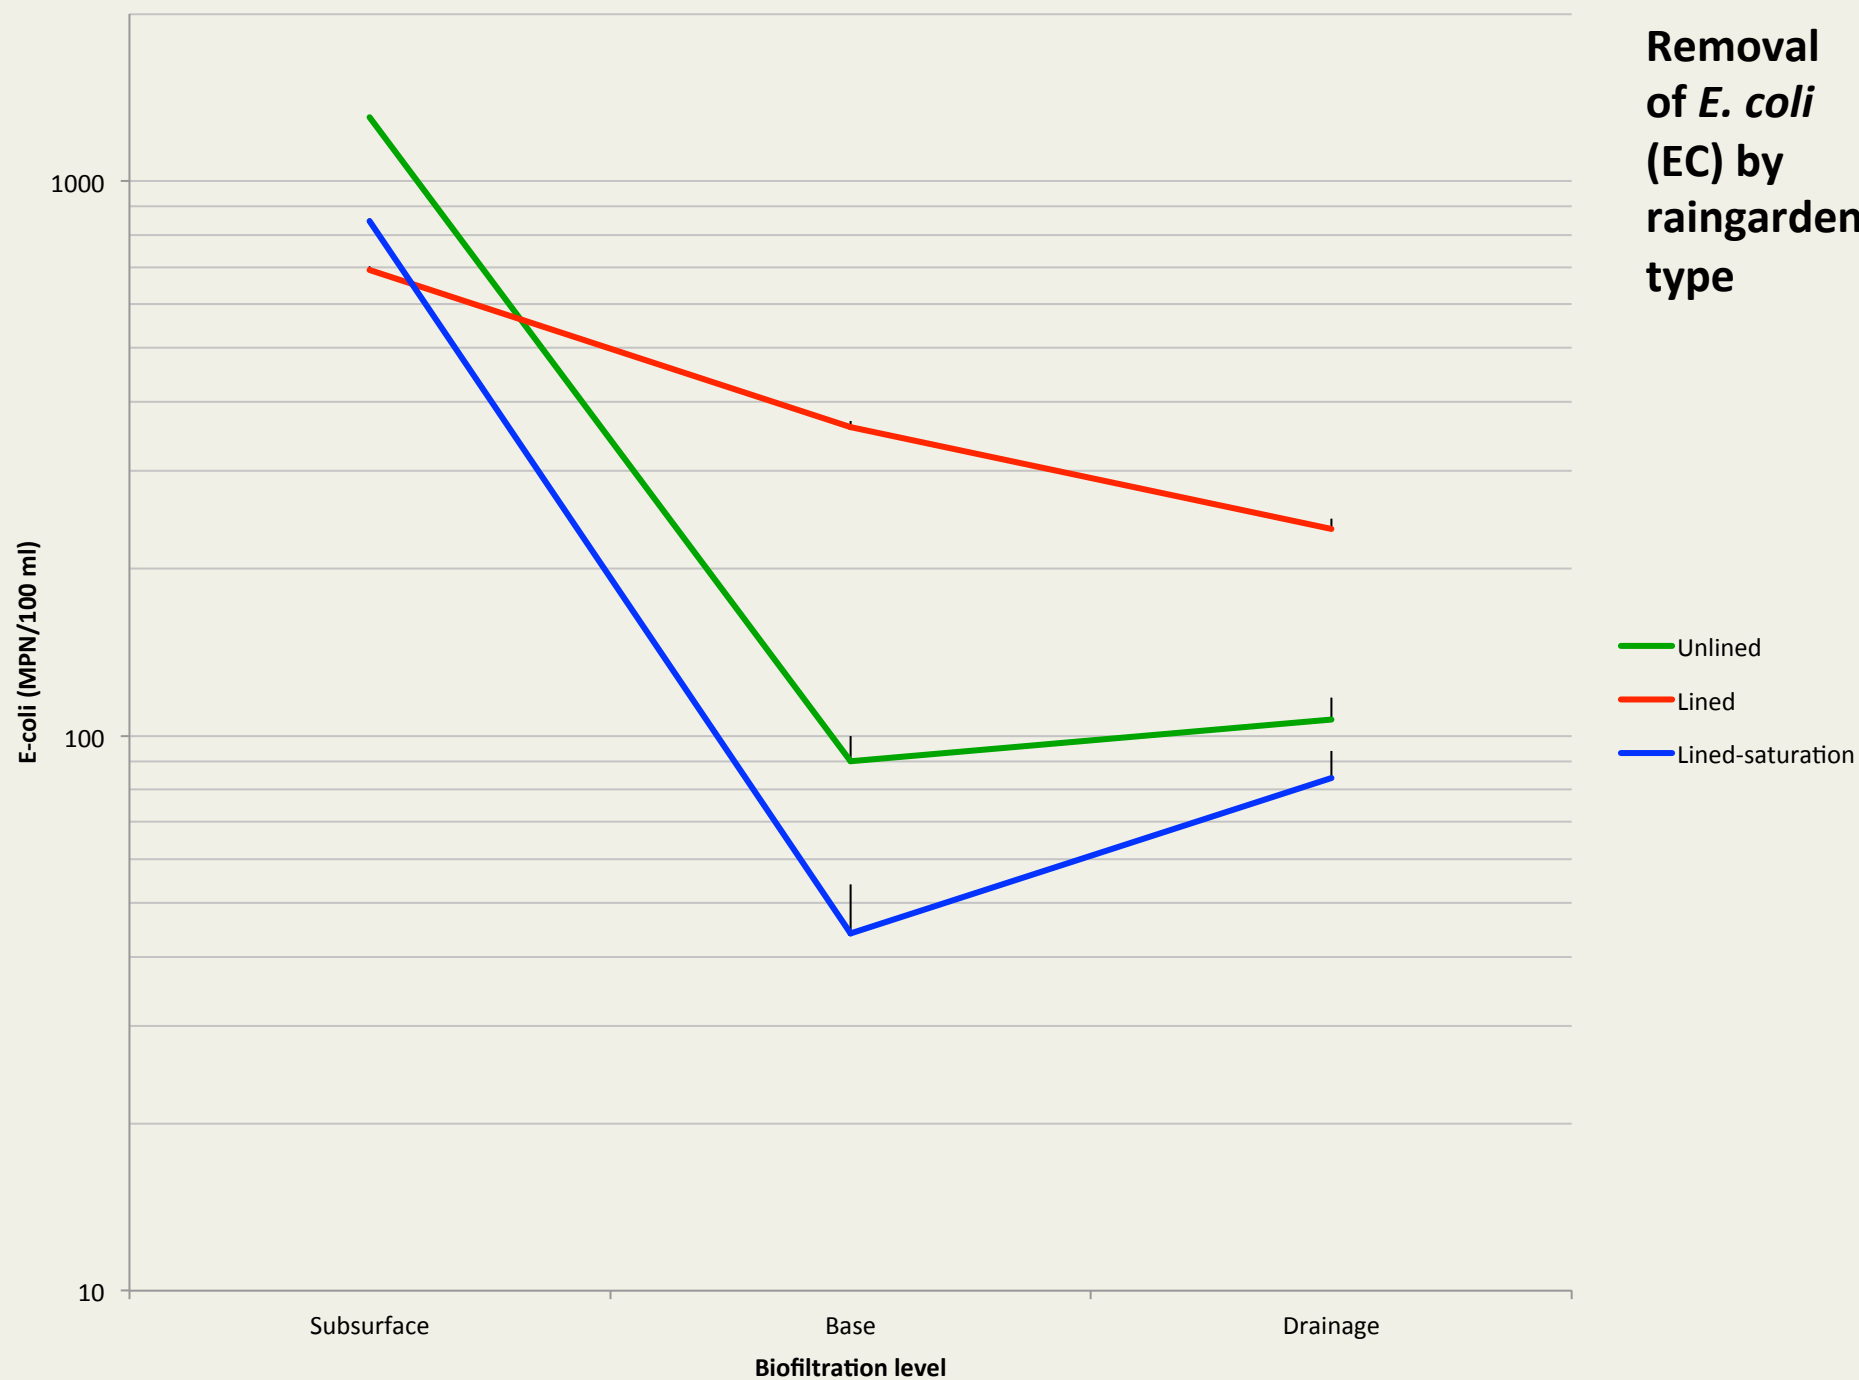
Removal of *E. coli* (EC) by raingarden type

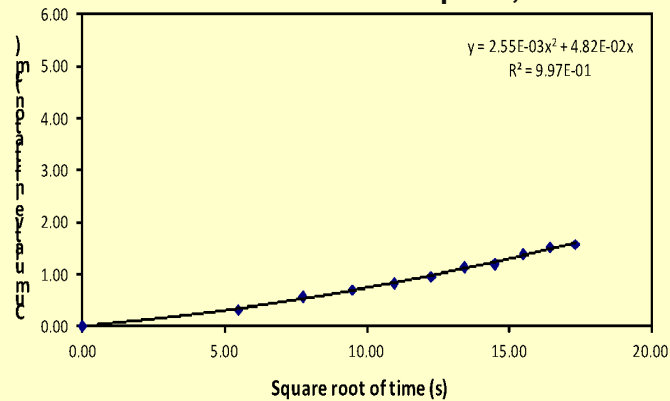
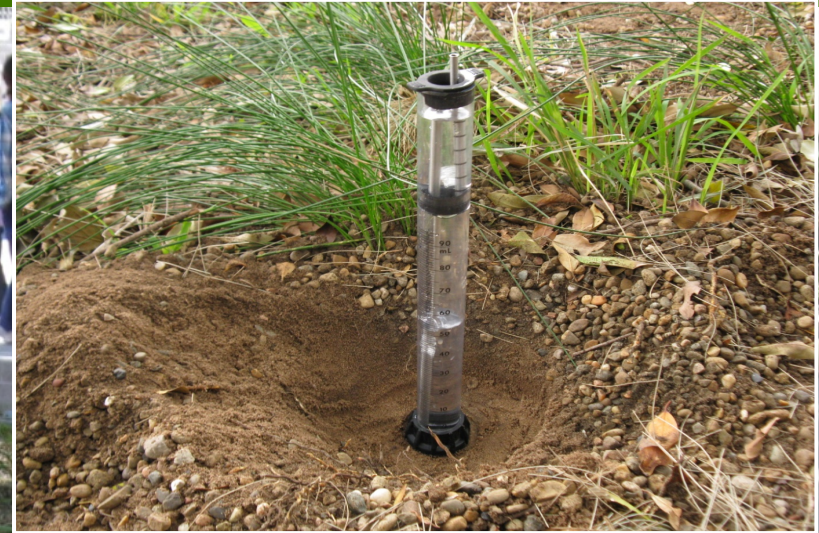
North Cope St, Redfern

Environmental performance: Micro-infiltrrometry

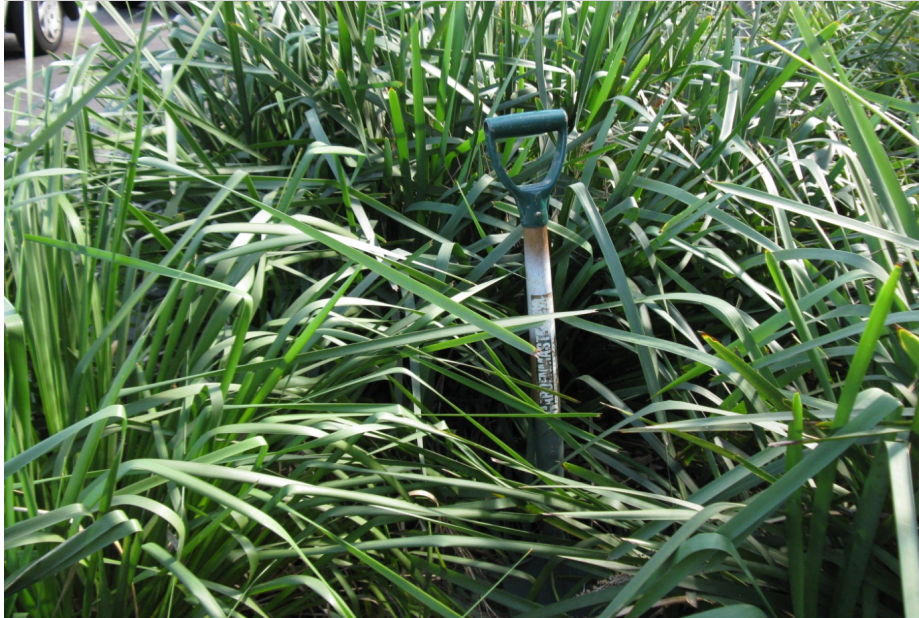
Mainly *Lomandra longifolia*, healthy, strong coverage

The two areas were compared for building operations, shade, infiltrometry, soil chemistry, etc.

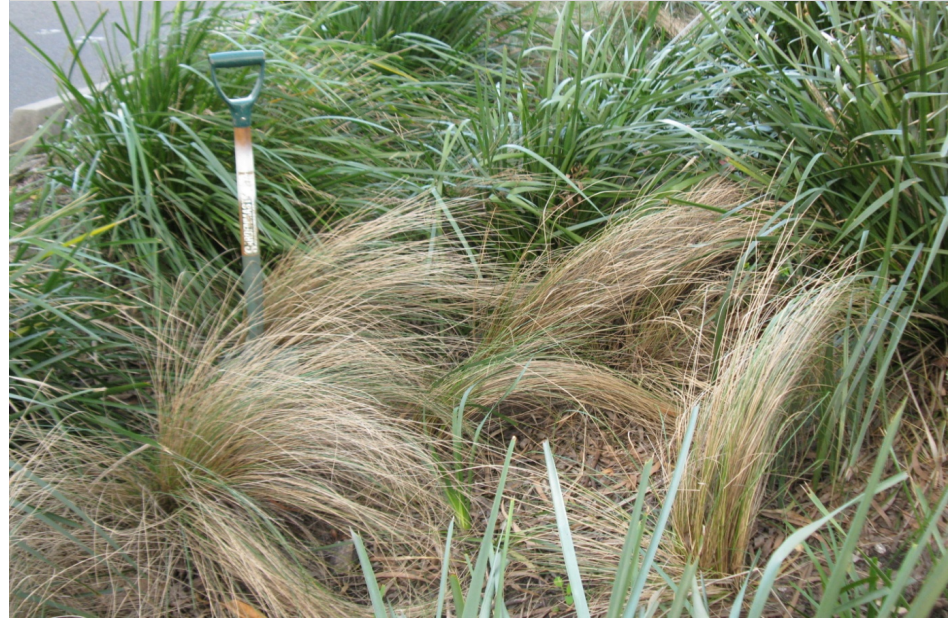
Juncus predominates, unhealthy, leaf die-off for all species
